Rejuvenation Project

Mossmorran Column Refurbishment

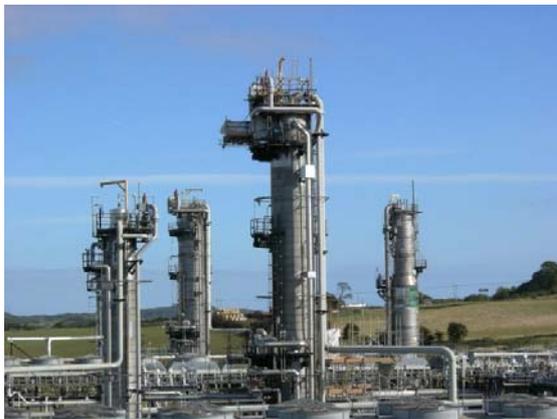
Module 2 & 3 Columns before refurbishment.

The original galvanised steel cladding had broken down allowing water into the Rockwool. In places the water was trapped and the Rockwool acted like a sponge retaining water inside the insulation and causing corrosion of the column.

During the refurbishment the columns 100% of the external surfaces of all nine columns were inspected, the coating system, insulation and cladding were all upgraded. The coating system was upgraded from a paint system to Thermally Sprayed Aluminium (TSA). The Insulation from Rockwool to Closed Cellular Glass and the Cladding from Galvanised steel sheeting to Stainless Steel.

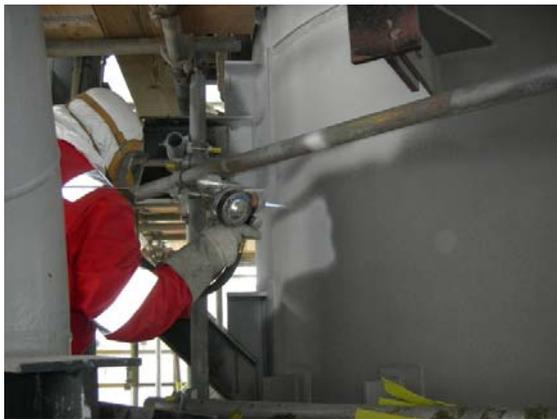
TSA being applied

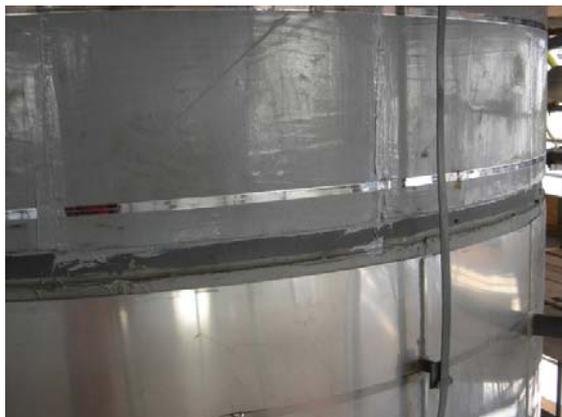
Insulation being applied, showing the Terostat coated Cellular Glass above Stainless Cladding.

The Closed Cellular Glass, Terostat and Stainless Cladding provide additional barriers to prevent the ingress of water, preventing future corrosion.

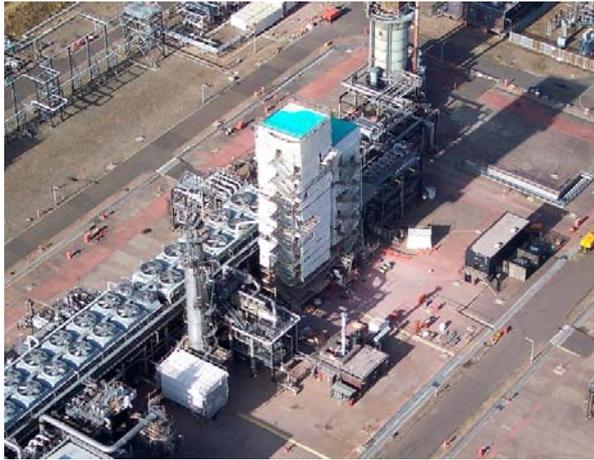
Module 1 showing 1-C1002 & 3 encapsulated.

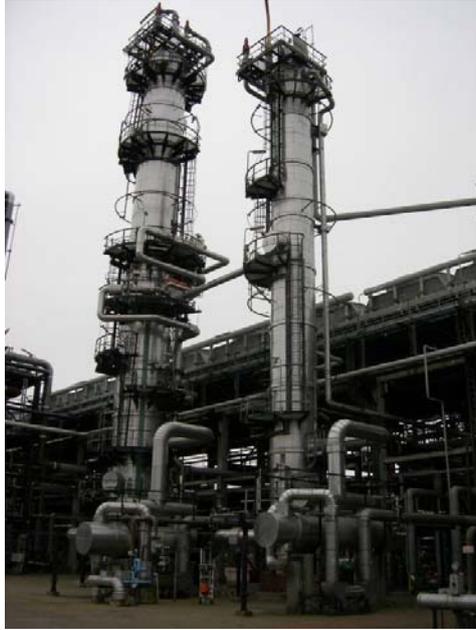
2-C1002 & 3 - Completed
